Tracking Generator and Reflection Bridge/VSWR Troubleshooting

Here are some common options for trouble with tracking generator/Reflection bridge/VSWR measurements

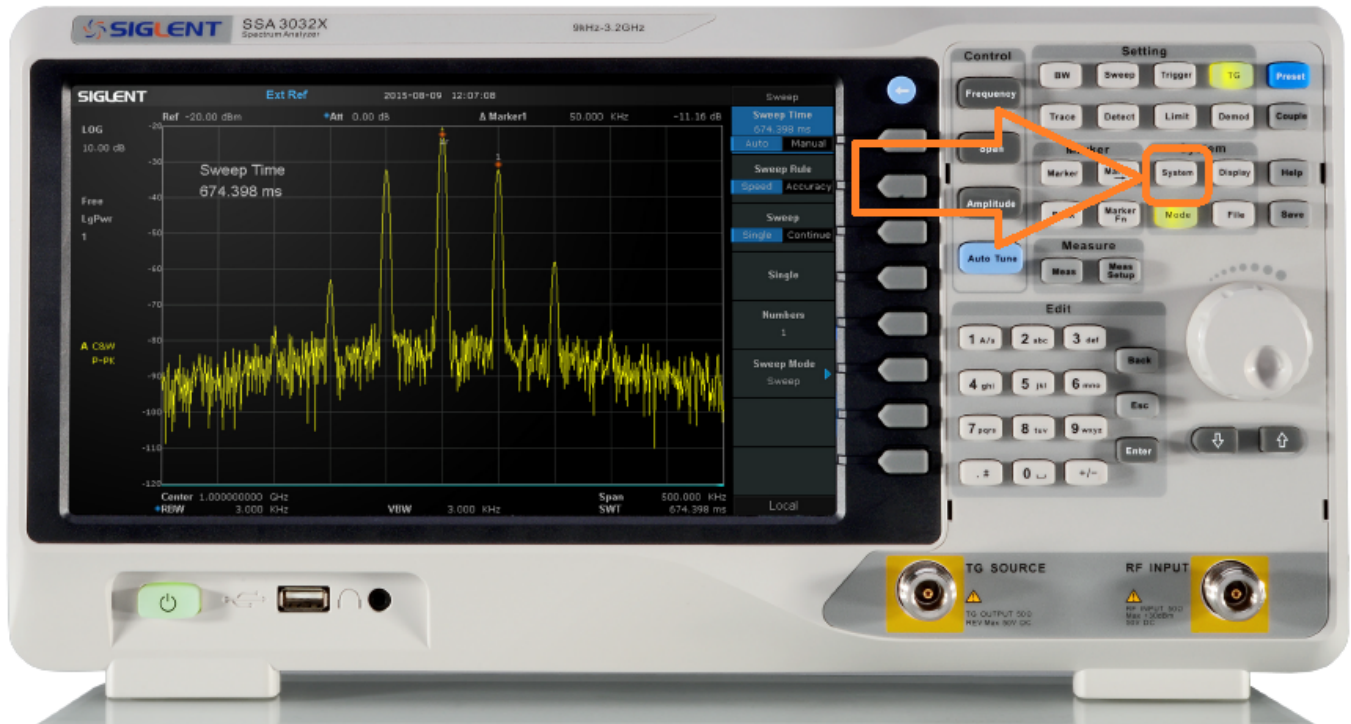
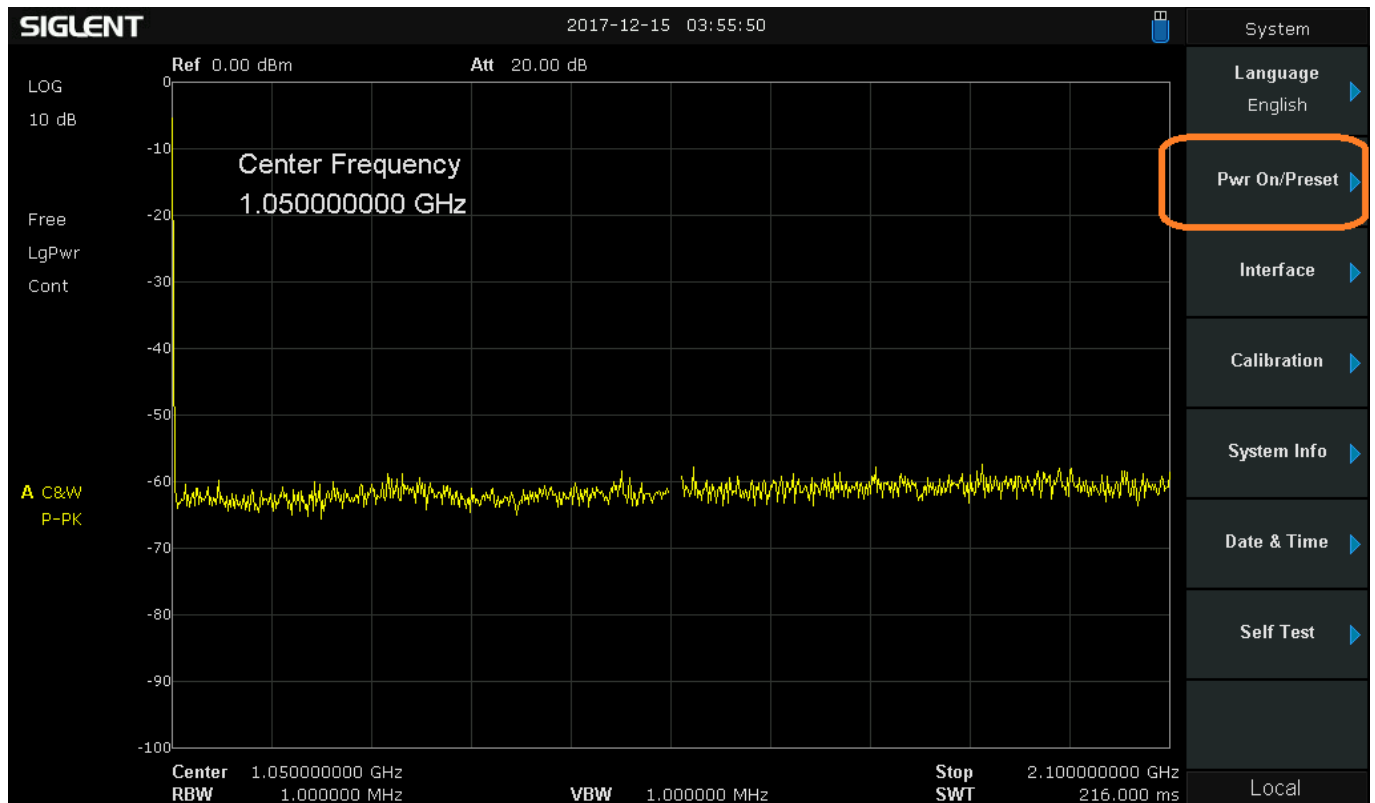
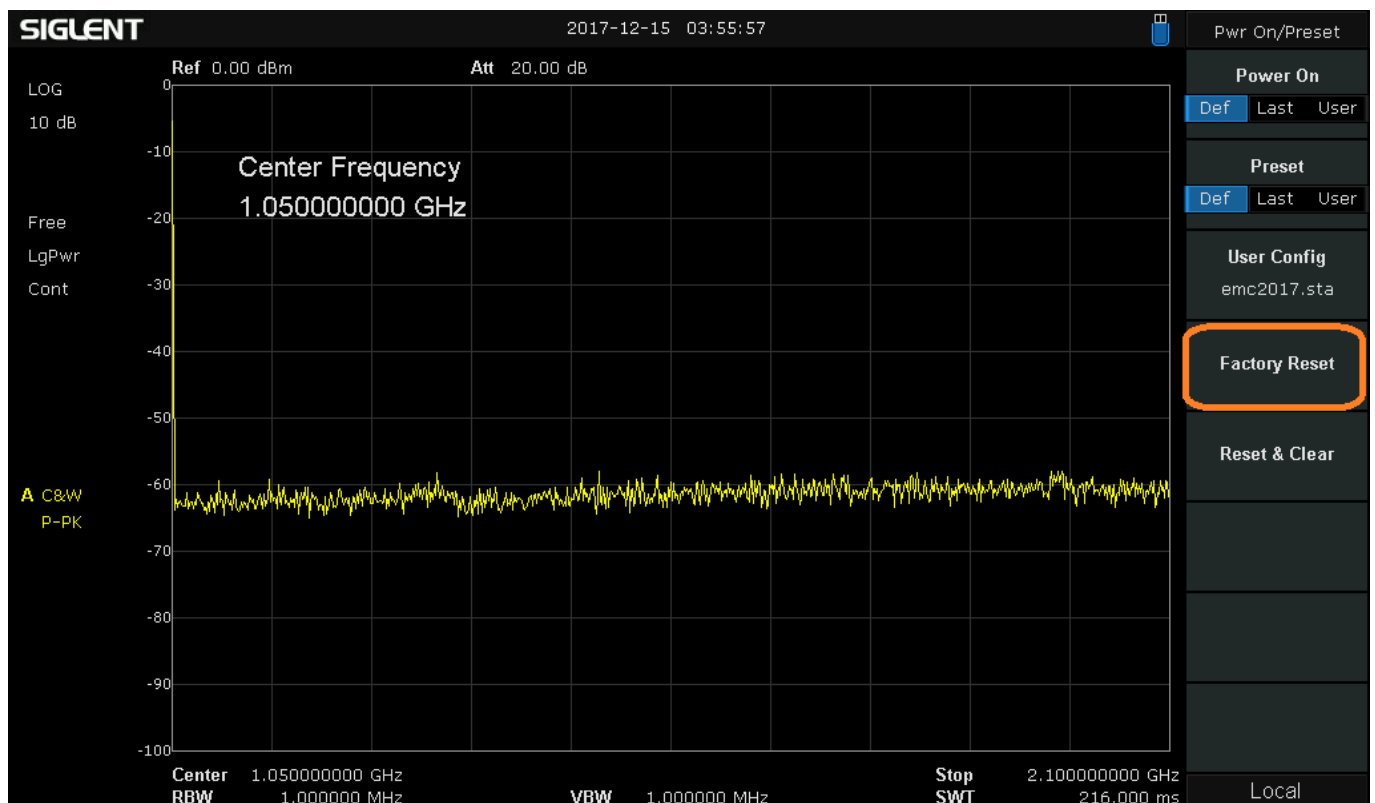
1. Set the instrument to factory defaults by pressing SYSTEM > PWR ON/Preset > Factory Reset

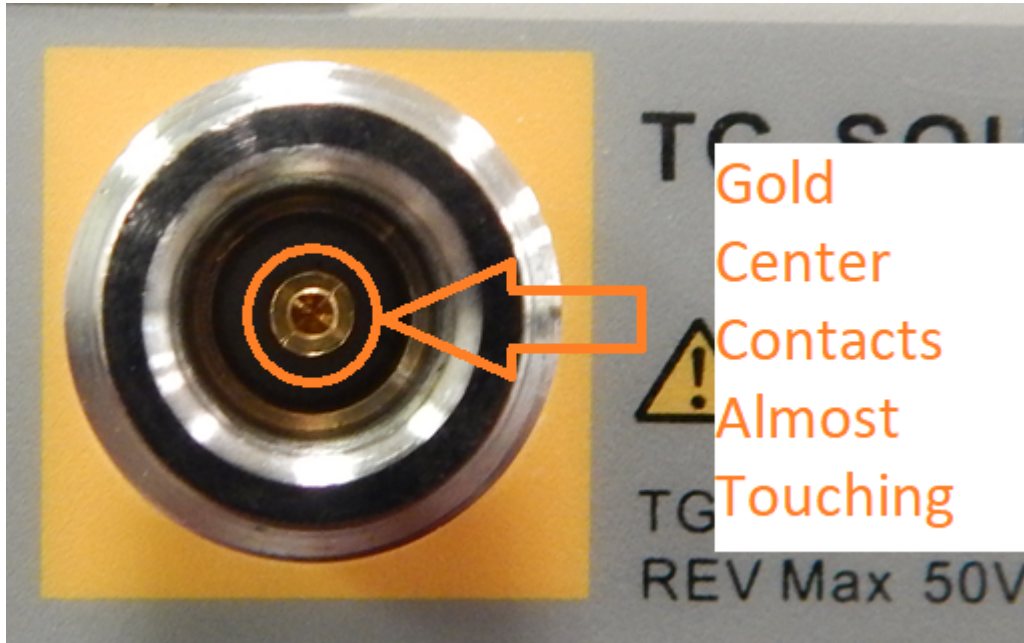
– Are the center conductor contacts very close to one another? No gaps and no broken/missing petals on the inner gold contacts?

Here is a good TG output connector:

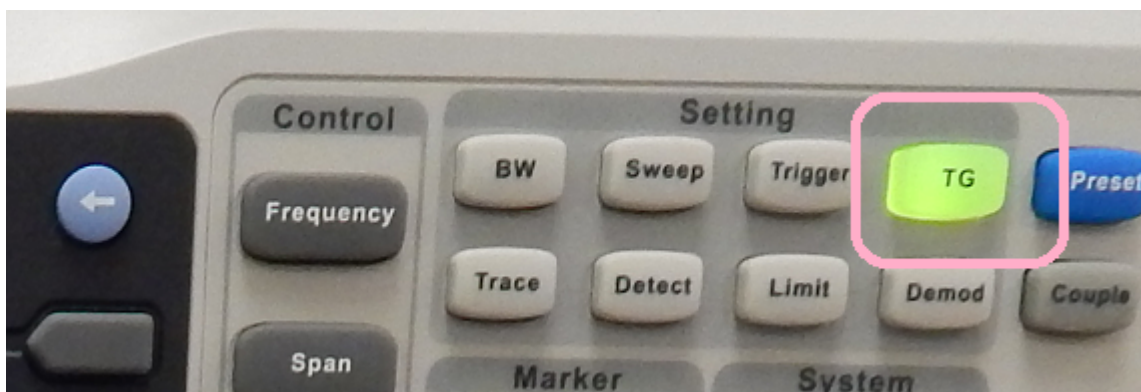
4. Is the TG output enabled? This is indicated by an illuminated TG button on the front panel:

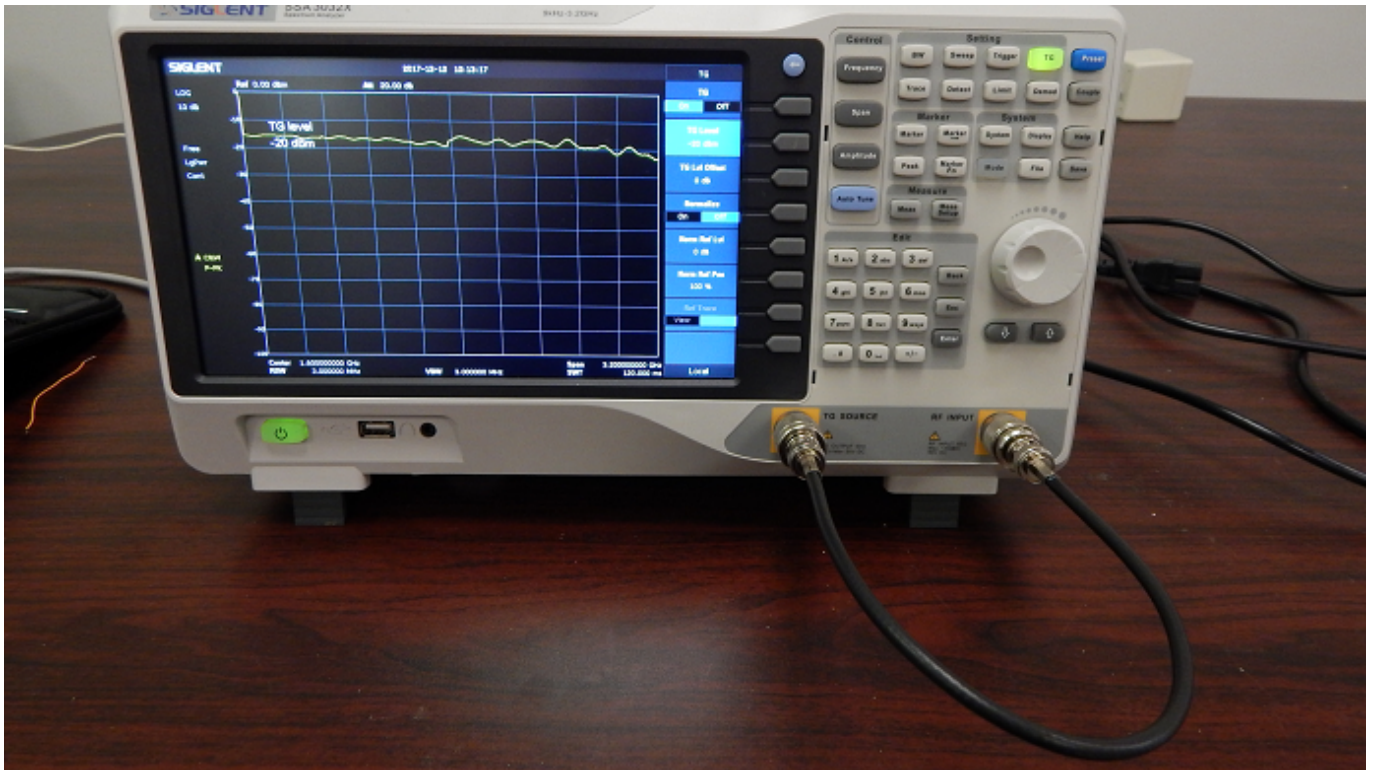
5. Does the TG level meet specifications when read directly by the analyzer?

Connect a cable from the TG output to the RF input and enable the TG:

The average output should be equivalent to the setpoint and the flatness should be within 3dB of that setpoint. If not, there is likely an issue with the TG, RF input, Cable, or connectors.

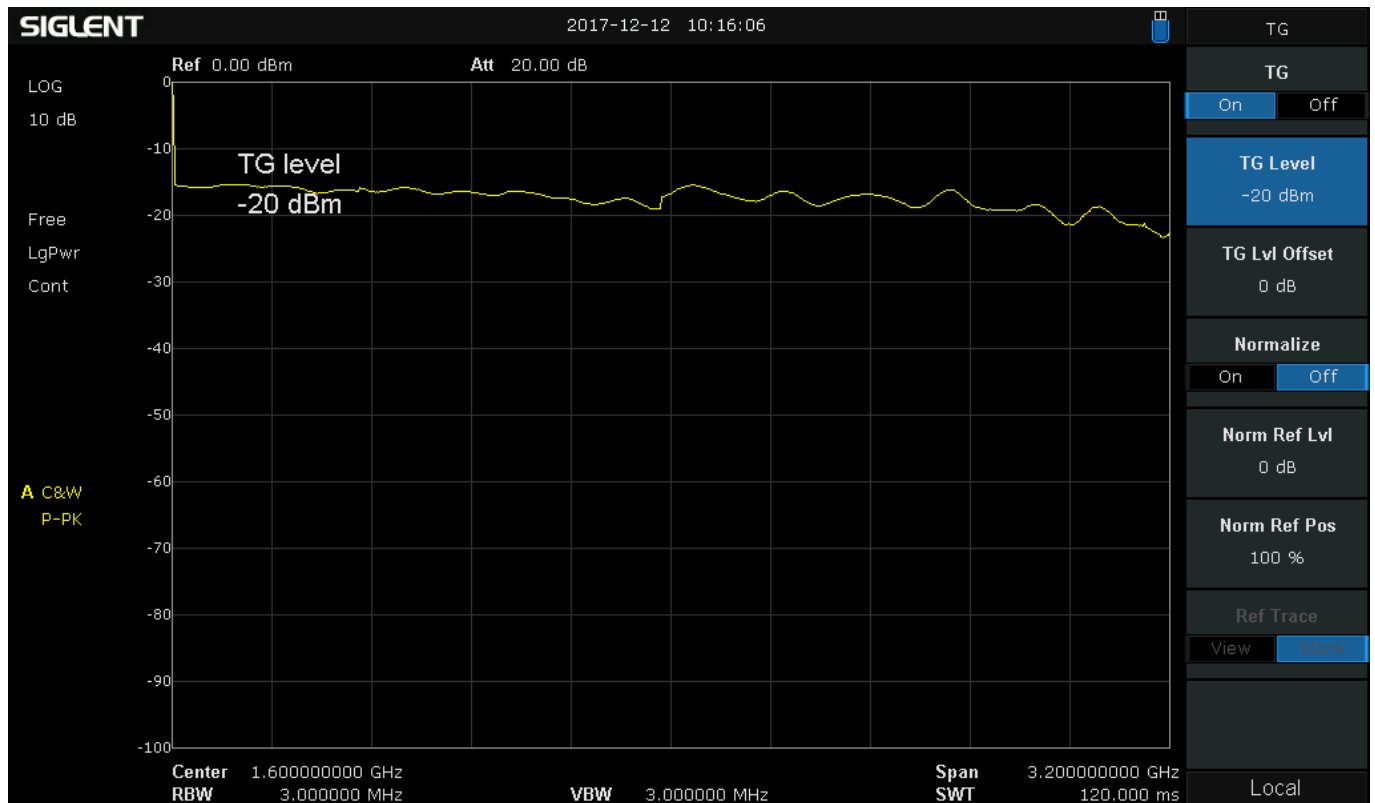
Here, the TG is ON, and is set to -20 dBm (TG Level)..

NOTE: There may be additional losses due to cable type, age, connectors, and any adapters that are in the signal chain.

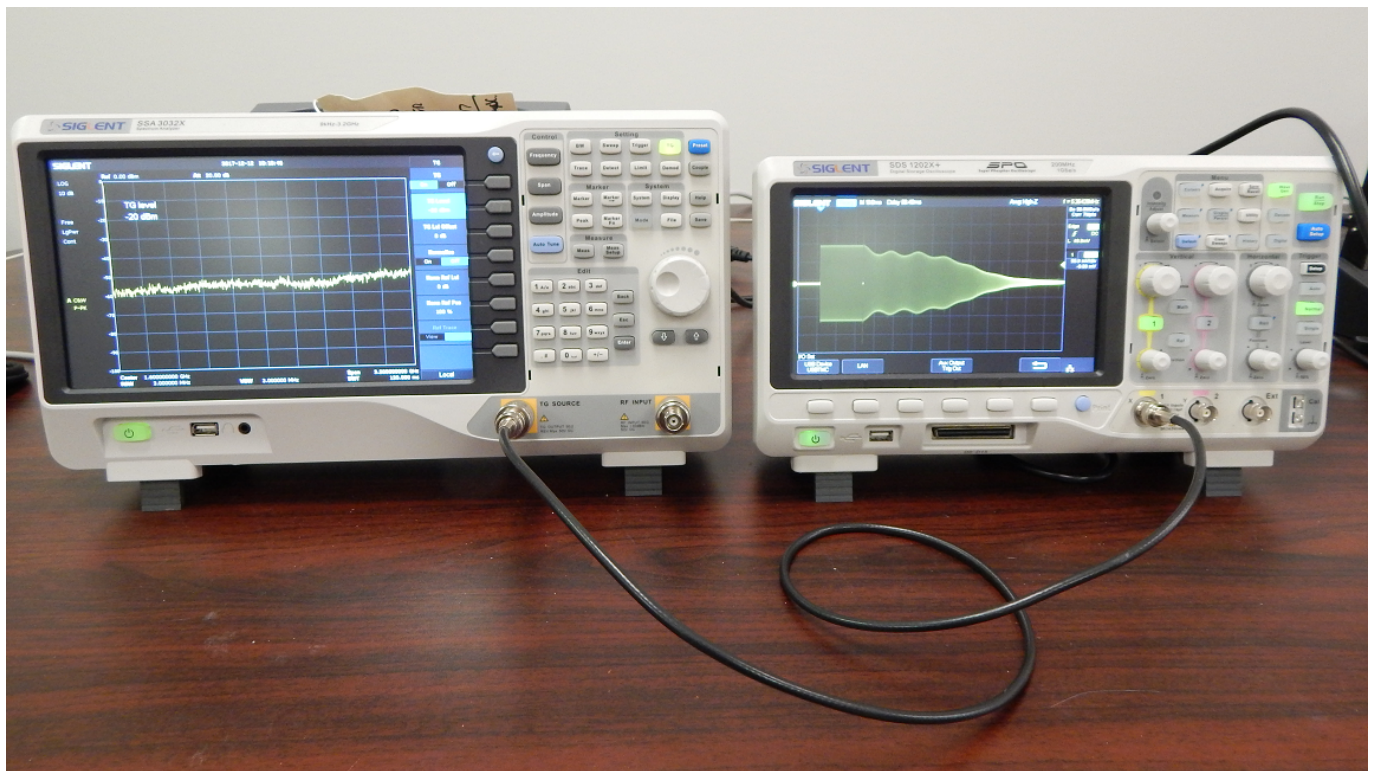
6. You can also check the TG output with an oscilloscope
